LAKE OKEECHOBEE and THE HERBERT HOOVER DIKE

*A Summary of the Engineering
Evaluation of Seepage and Stability
Problems at the Herbert Hoover Dike.*

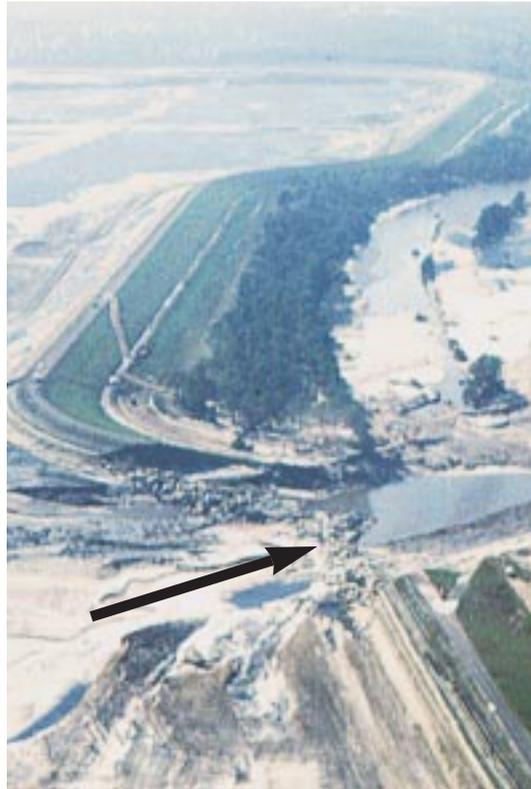
Breach of Florida Power and Light Cooling Reservoir, 1979. Failed due to piping of material from the foundation of the dike.

The nearby Florida Power and Light Cooling Reservoir Dike failed in 1979 causing considerable flooding damages. It failed as a result of piping through its foundation.

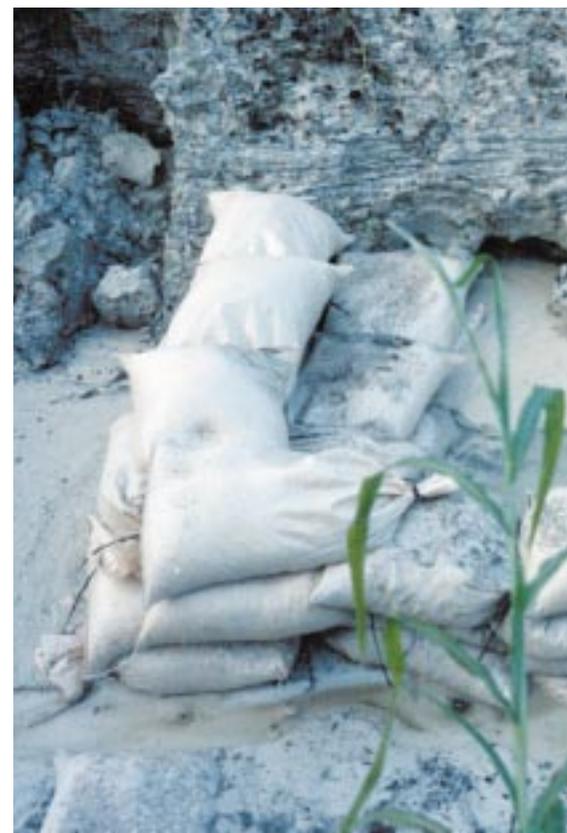
Sandbagging and piping at Lake Harbor showing mound of piped material that is flowing from the dike.

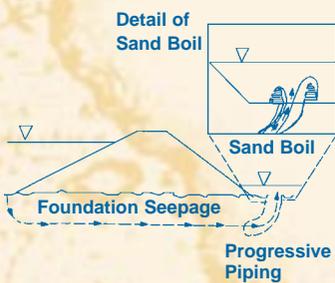
FOUNDATION PIPING

Piping — the erosion of soil caused by water. As the soil erodes, it creates an open path (a “pipe”) through which water can pass. As more and more soil erodes, the pipe gets larger.

This erosion of soil is technically known as *piping*. The piping of the soil creates a continuous open path through which water can erode even more soil. If this soil erosion is allowed to continue, it will eventually create large cavities in the dike.

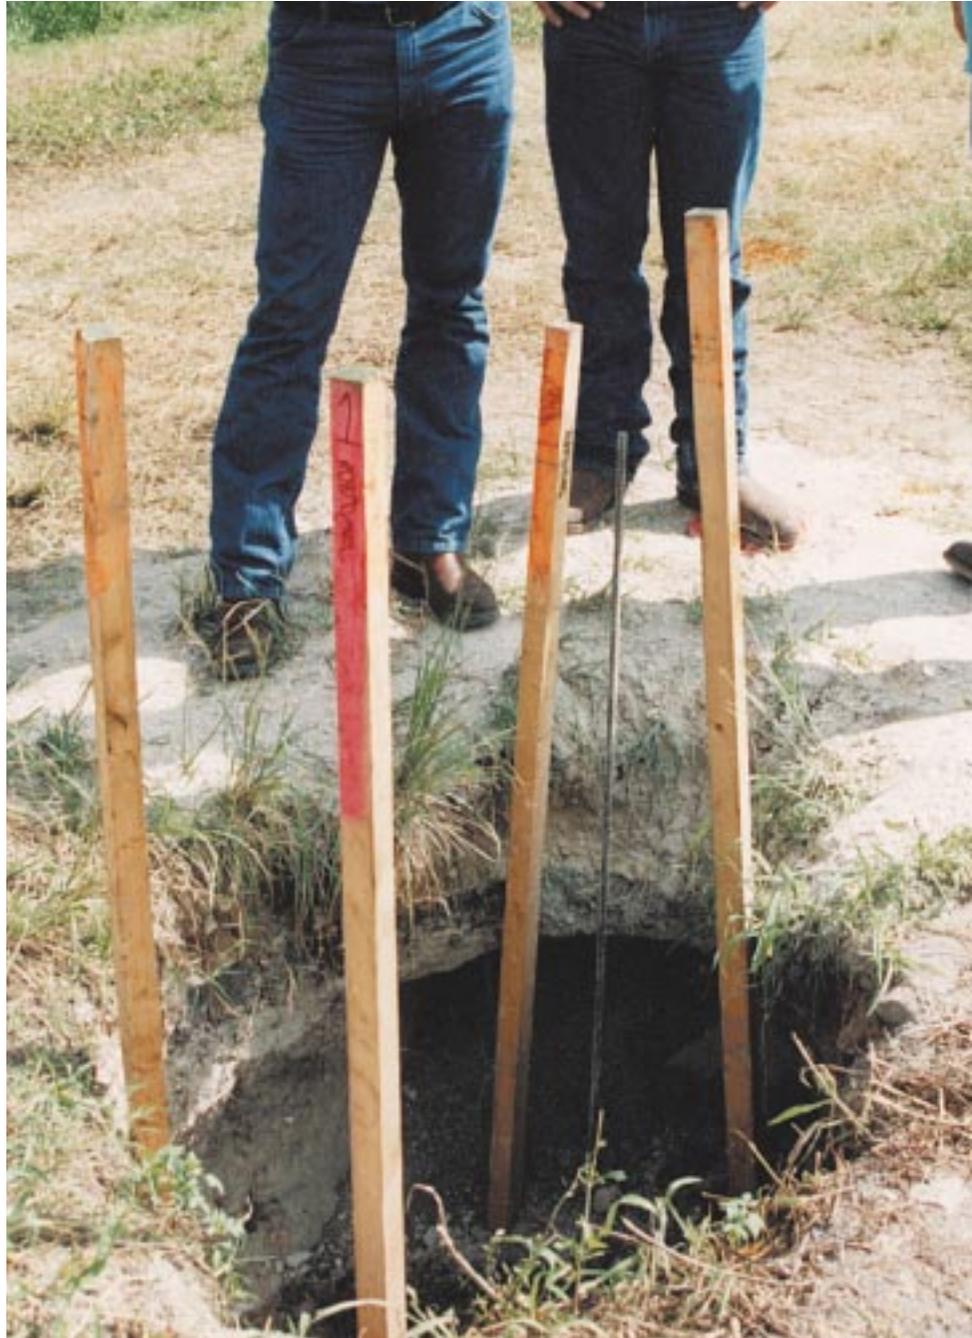
Sinkhole on levee crest at Lake Harbor site.

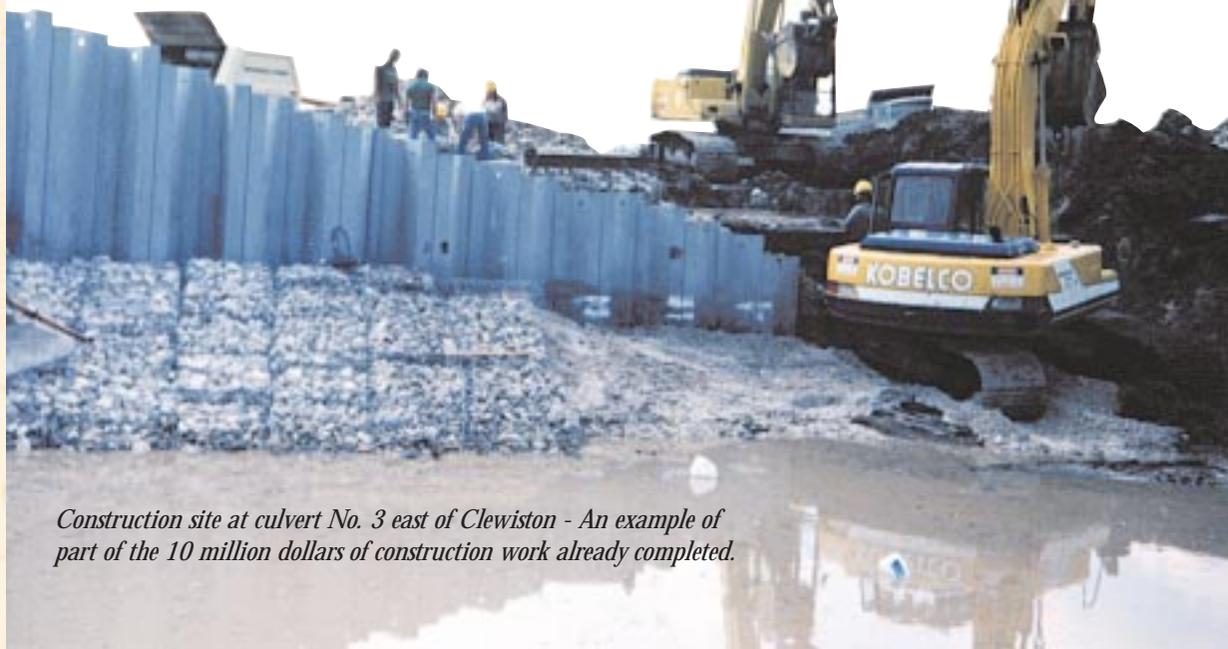
Construction site at culvert No. 3 east of Clewiston - An example of part of the 10 million dollars of construction work already completed.
